Flood Recovery

2007

Ross Lake National Recreation Area, Lake Chelan National Recreation Area, North Cascades National Park

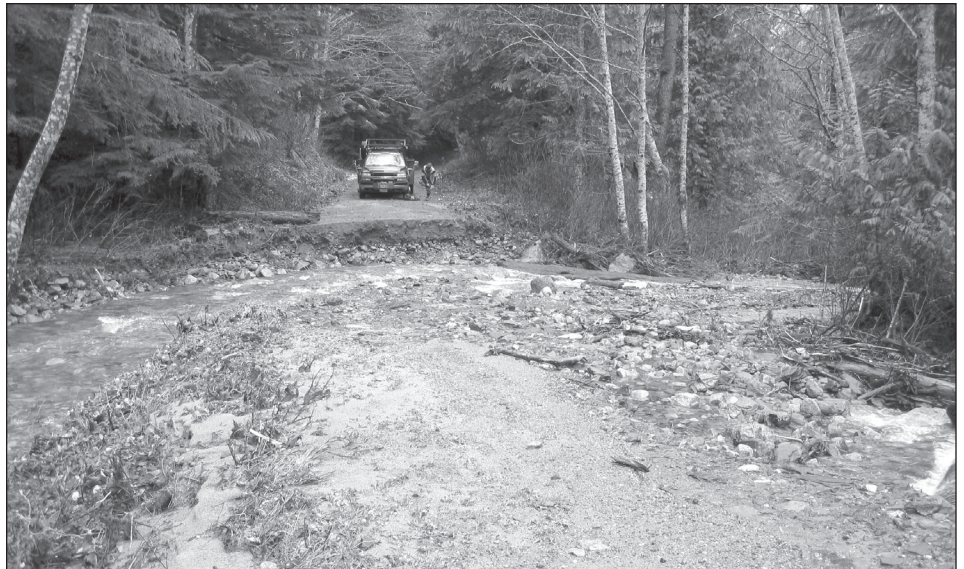
Figure 1. Cascade River Road at milepost 20.5. The North Fork of the Cascade River carved a new channel through 300 feet of the road.

Milepost 20.5: The North Fork of the Cascade River carved out a new channel along 300 feet of the former roadbed, (Figure 1). Most of the river is now flowing down this new channel and no longer flowing under the bridge at milepost 20.6. An Environmental Assessment will be prepared to address this damage.

Two preliminary alternatives currently under consideration include: (A) repair the road with causeway and culvert; or (B) repair the road with a causeway and second bridge. Both alternatives may require bank stabilization to keep the river in established channels. Installation of a bridge would be more expensive but less harmful to the ecology of the river. A bridge would also be less likely to fail in future floods. Prior to designation of the Stephen Mather Wilderness in 1988, the river washed out this

(Continued from page 1) section of road. An excavator was used to dredge the river channel and keep the river flowing under the bridge. Rock-filled gabions were also installed to stabilize the river bank. The Stephen Mather Wilderness boundary now lies on 50-feet on either side of the centerline of the Cascade River Road, so all repair actions, including manipulating the river channel, must comply with the Wilderness Act.

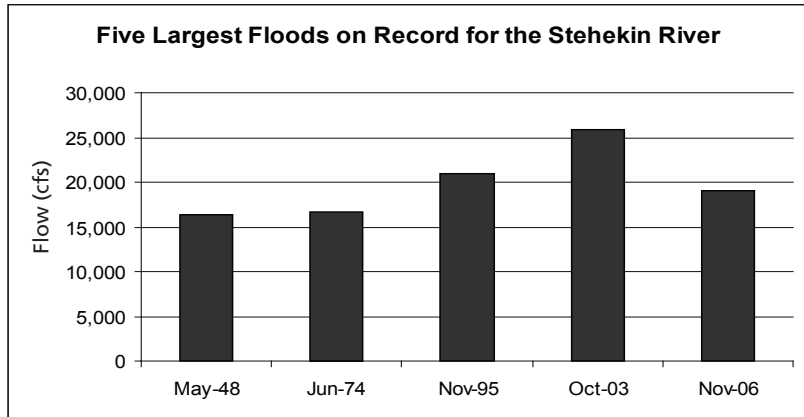
This was the third largest flood of record on the Stehekin River. None of the flood damage, however, should affect use and enjoyment of the Stehekin Valley this coming season. But the Stehekin River is flooding with much greater frequency and intensity than in years past (Figure 2). This new pattern of severe flooding is causing substantial damage to public and private property in the lower Stehekin Valley.

Figure 2. The three most recent Stehekin river floods all occurred in the fall following rapid warming and “rain on snow” events. The extremely low probability of these 100+ year floods in such succession, coupled with rapid glacial retreat, suggest that climate change is causing increased flooding in the North Cascades.

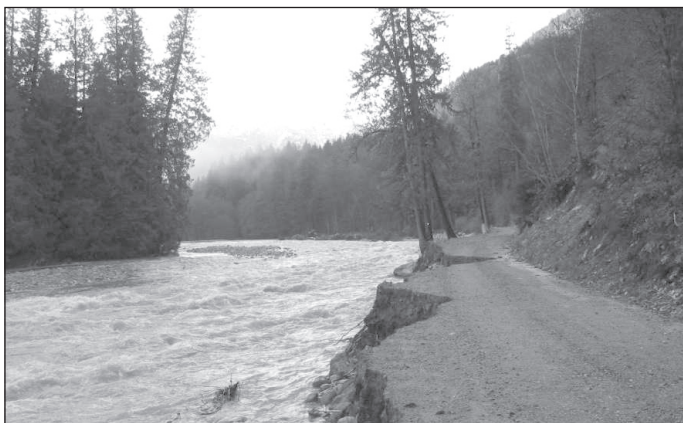
The flood collectively scoured one mile of roads in several locations. The worst damage occurred on the Stehekin Valley Road at milepost 8 (Figure 3), temporarily blocking vehicular access to residents of the Stehekin Valley Ranch and points beyond. NPS staff in consultation with the Army Corps of Engineers took emergency action to repair the road by installing approximately 100 cubic yards of rock and fill to form a single lane.

Figure 3. Flood damage to approximately 200 feet of the Stehekin Valley Road at milepost 8. The NPS repaired this damage with 100 cubic yards of rock.

The National Park Service plans to install several additional “bank bars” (erosion control structures), plant riparian vegetation and raise the grade of the roadbed one to three feet to prevent further flood damage (described in the November 2005 Finding of No Significant Impact: Stehekin Valley Road Improvement Project). Bank barb construction should begin in early spring 2007 to minimize flood damage caused by spring snowmelt, however, the road may not be completely repaired until next fall.

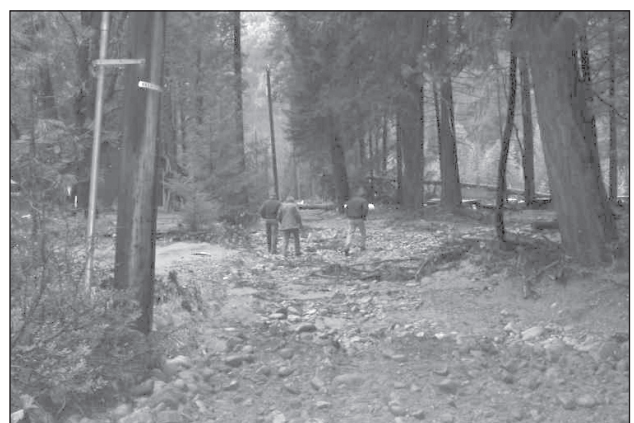
The flood damaged the lower and upper portions of the Company Creek Road on the lower west side of the Stehekin River Valley (Figure 4). Harlequin Campground was completely submerged and the entrance road was substantially scoured. The campsites were buried in 1 foot of sediment and vault toilets were flooded. Every effort will be made to open the campground by Memorial Day weekend. Relocation of the restrooms is currently under consideration given the regular flood damage and water quality concerns.

Figure 4. The Stehekin River flowed directly down the Upper Company Road, scouring the road surface and flooding several houses.

At the upper end of the Company Creek Road the NPS conducted emergency repairs on an existing rock hump (water diversion structure) and installed two more rock humps to prevent future flood waters from running down the road unimpeded. The road was also resurfaced using gravel salvaged from the road and additional material from the Company Creek pit.
